JULY 2011 • VOLUME 1, ISSUE 1

WHAT IS THE PURPOSE OF THIS REQUIREMENT?

AIR LEAKAGE CASE STUDY:

An Energy Concern but also a Source of Envelope Failure

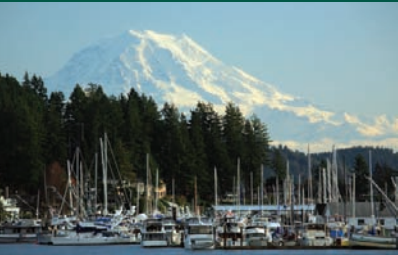
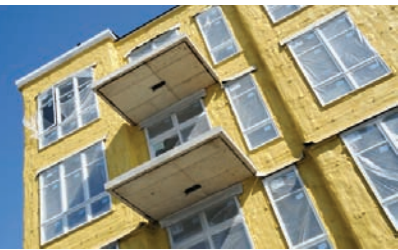
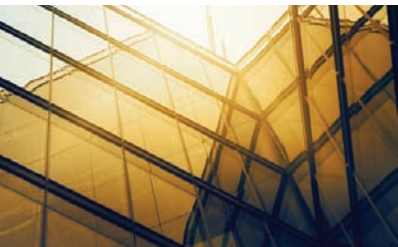
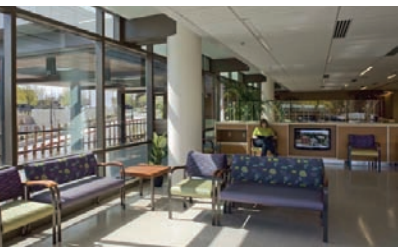
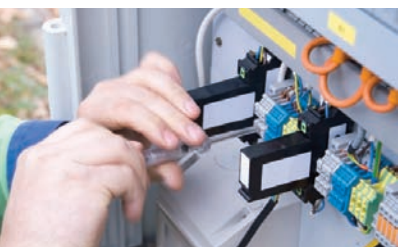
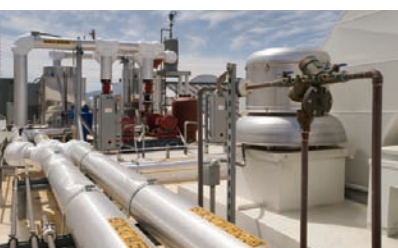
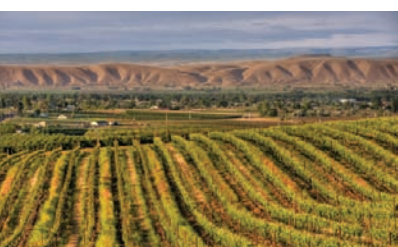
In a sample of 203 commercial buildings, the average measured air leakage was 1.55 cfm per square foot of above grade envelope area when tested at 0.3 inch w.g. (1.57 psf, 75 Pa) pressure difference.

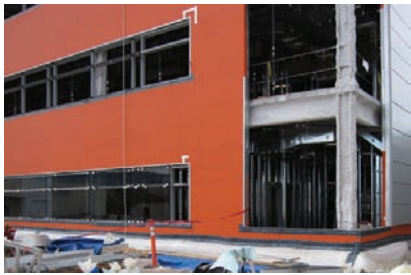
Figure 3.
Installation of fully adhered air-barrier (orange membrane) including self-adhering flashing in progress in Central Washington.

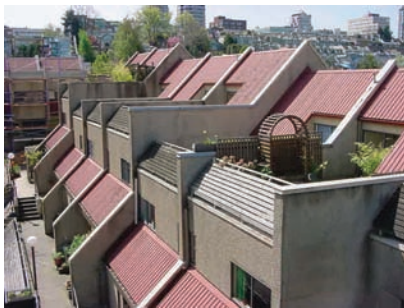
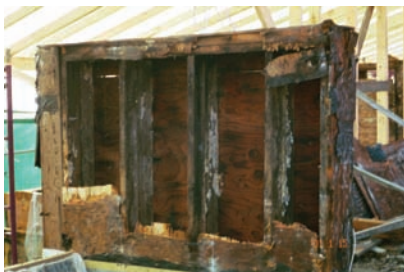
In the case of a 1976 low-rise wood-framed residential complex in the Pacific Northwest, air leakage was the cause of 25% of the damage, which required complete envelope rehabilitation. Stucco clad exterior partition walls separate roof decks, suite entrances, and balconies. These architectural features were extended to include stucco wall build-outs and metal capped roof build-ups. The roof consists of inverted flat roofs and sloped metal roofs.

After previous waterproofing repairs proved unsuccessful, a detailed building envelope investigation was conducted. Black staining and mold growth were consistently observed on the interior surfaces

of the partition walls and roof build-ups. Damage was often greater on the interior surfaces of the framing and sheathing rather than on the exterior.

The party walls consist of 2x4 double stud walls with a gap of one to two inches between the walls. Partition walls, roof decks, and roof build-outs consist of wood frame extensions of the party walls.

Heated air in a building is buoyant and exerts pressure on the envelope. By the principle of Stack Effect, warm moist air migrated from the interior of the building into the party walls, then up into the partition walls above the roof/deck line. Acting as a chimney from the crawlspaces

to the roof, the party wall configuration allowed interior air to rise and accumulate in the uninsulated partitions and roof build-outs, where it condensed on the cold surfaces, leading to rot and failure. The leakage of warm air through the partition wall was so significant that during rehabilitation, condensation was observed on the plastic tarps used to cover the partition walls that were being repaired.

The areas of most advanced decay were those affected by the combination of water leakage (from outside) and air leakage (from inside). As in this case, problems due to air leakage are not often visible from either the interior or exterior of the building. As such, air leakage issues can go overlooked and unaddressed for years. In this case, building configuration and architectural elements, lack of air barrier continuity, and a lack of designed ventilation for the affected elements, and extended exposure of exterior void spaces to warm air were contributing factors to the failure.

The successful repair consisted of creating a plane of air tightness using expanding polyurethane spray foam insulation where party walls penetrate the plane of the flat roof and venting the partition walls. The repair minimizes the amount of air leakage into the partition walls and uses venting to allow any moisture that does migrate from interior spaces into the partition walls to evaporate to the outside.
